# **INSPECTION REPORT**

***Project No. DT-15803***

**PROPERTY LOCATED :**  
**103 White Marsh Ln, Rotonda West, FL 33947**

**EXHIBIT I - PHOTOGRAPHS**

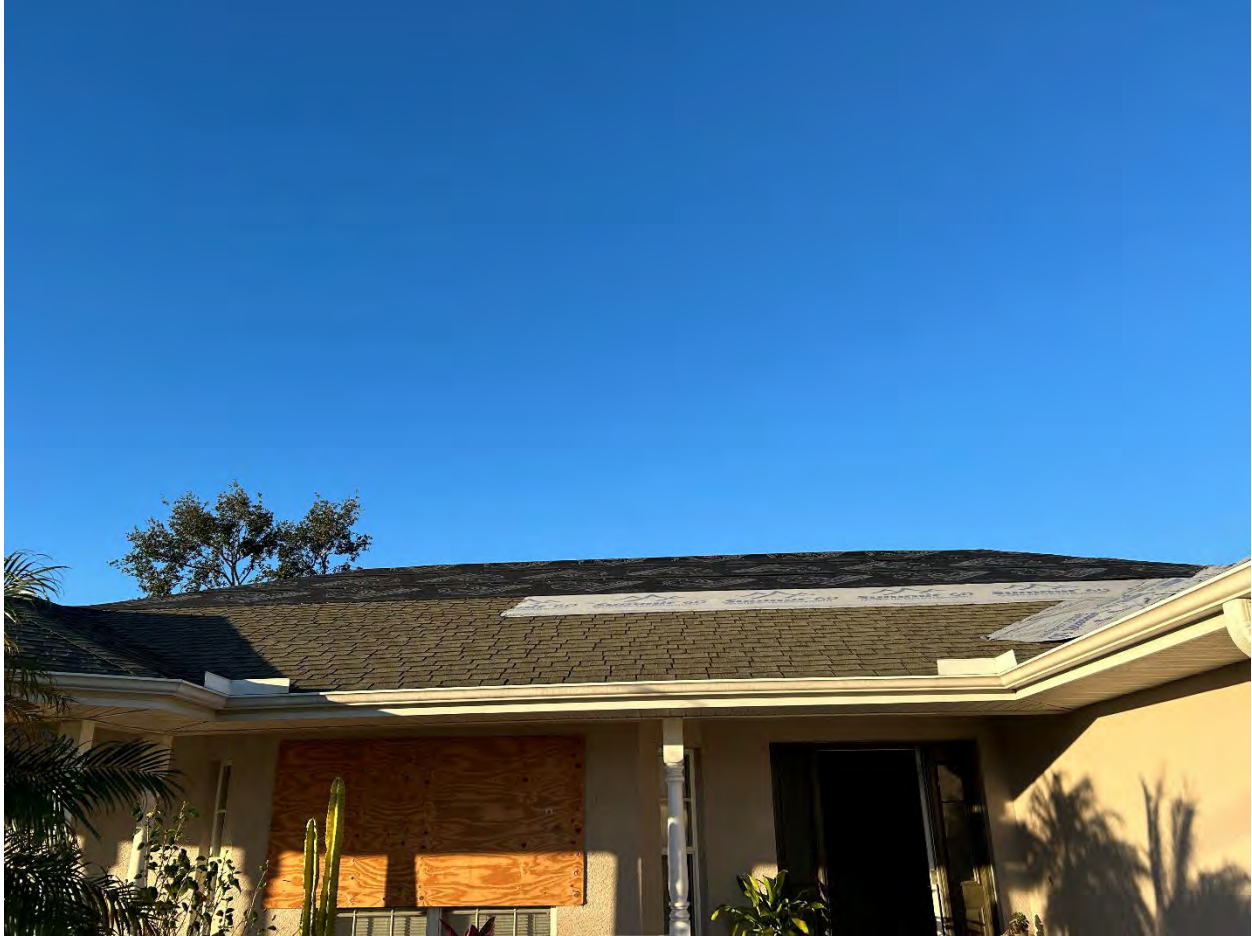
**SHINGLES FALL APART ALL OVER THE ROOF**

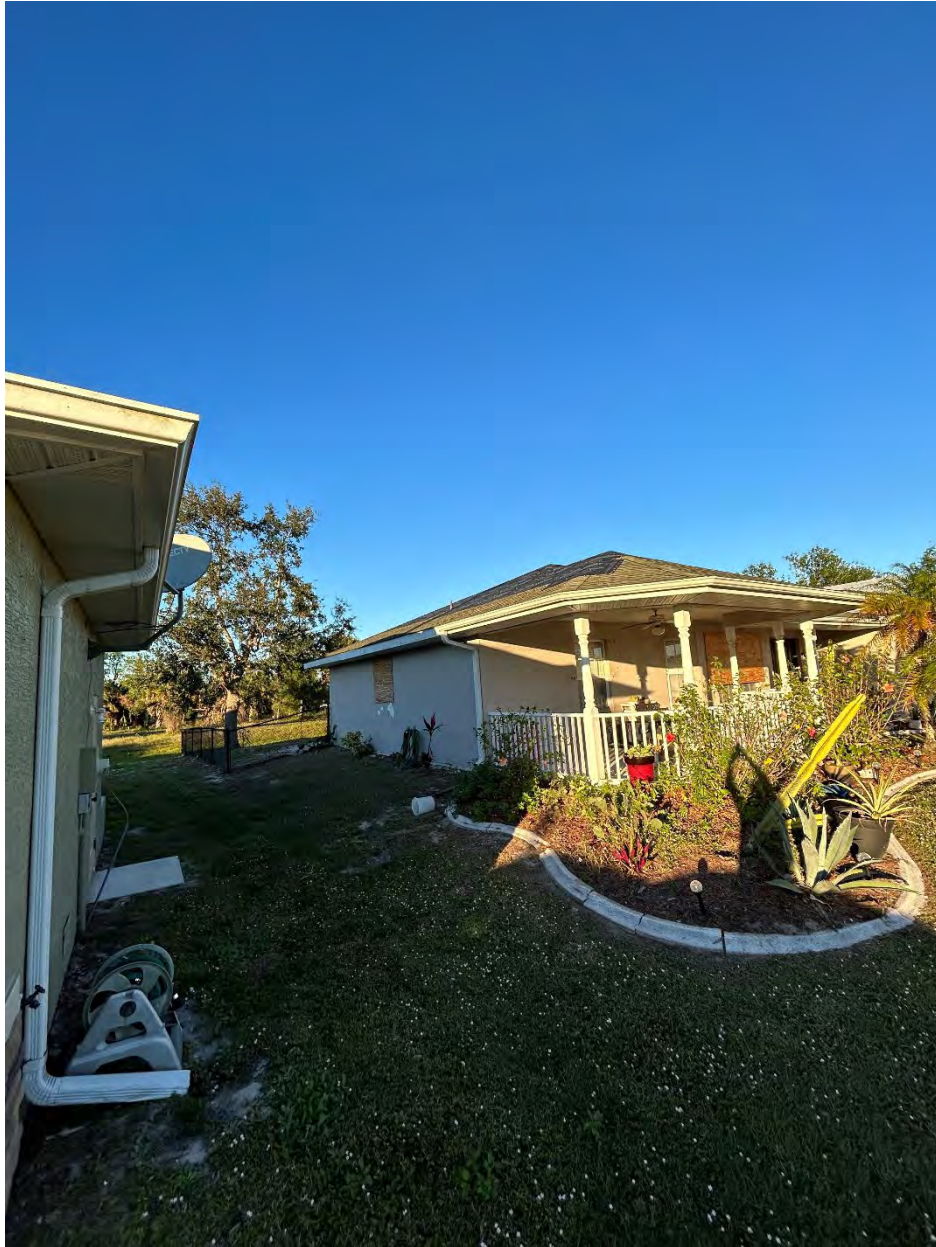
**SHINGLES FALL APART ALL OVER THE ROOF**  
**PAINTING NEEDED**

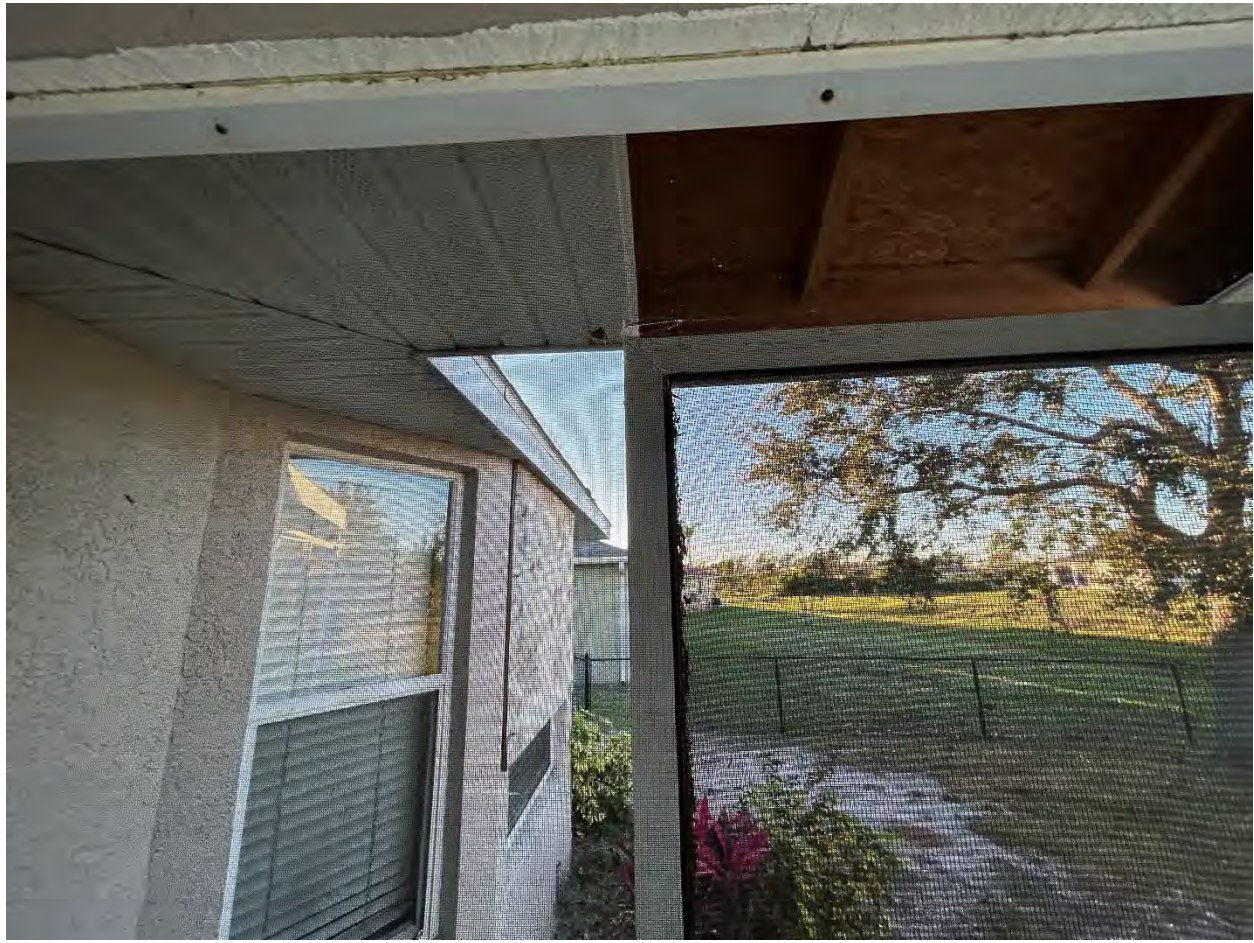
**INEXISTENT ROOF ALUMINIUM  
SCREENS DAMAGE**

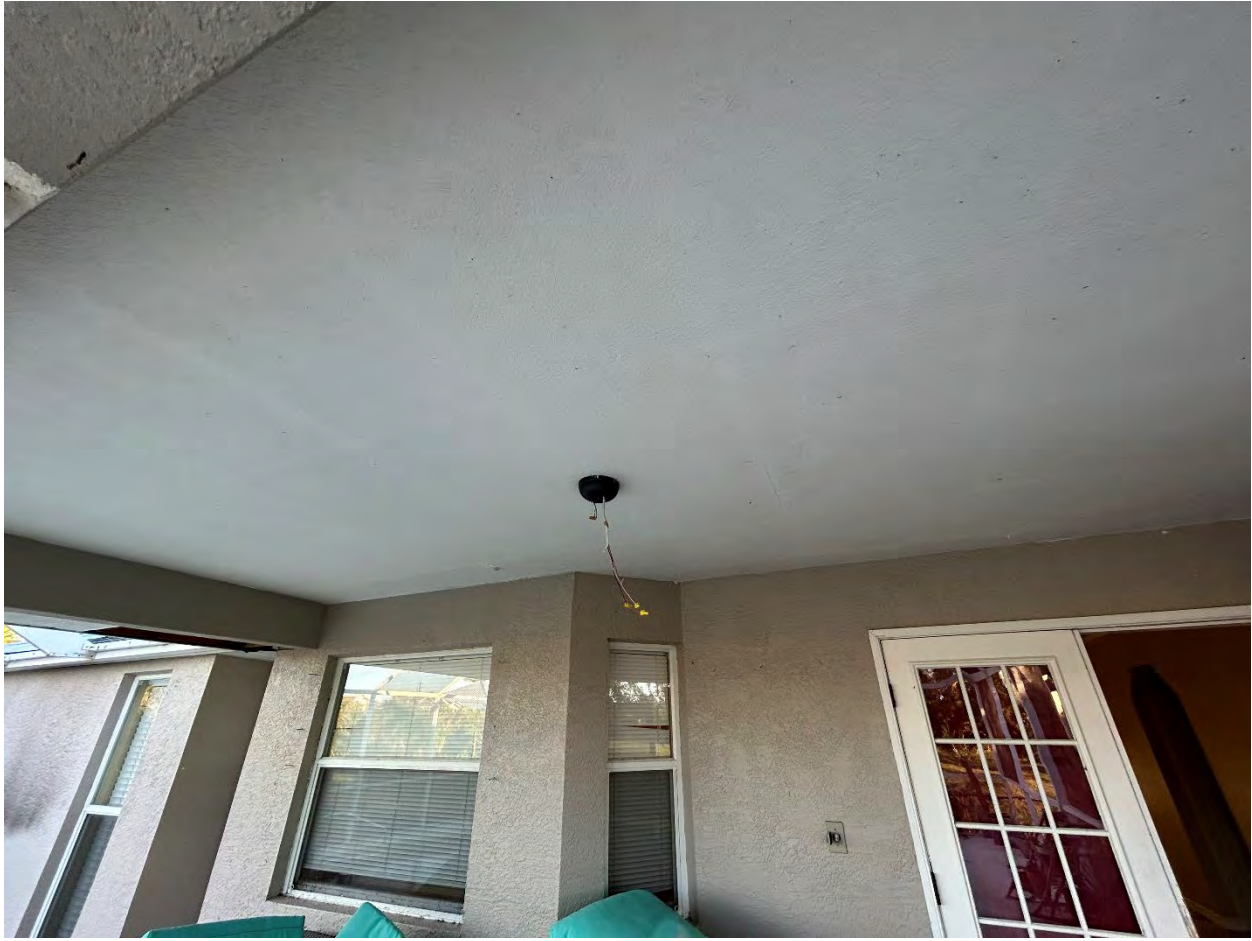
**FAN CEILING MISSING**  
**EXTERIOR PAINTING**

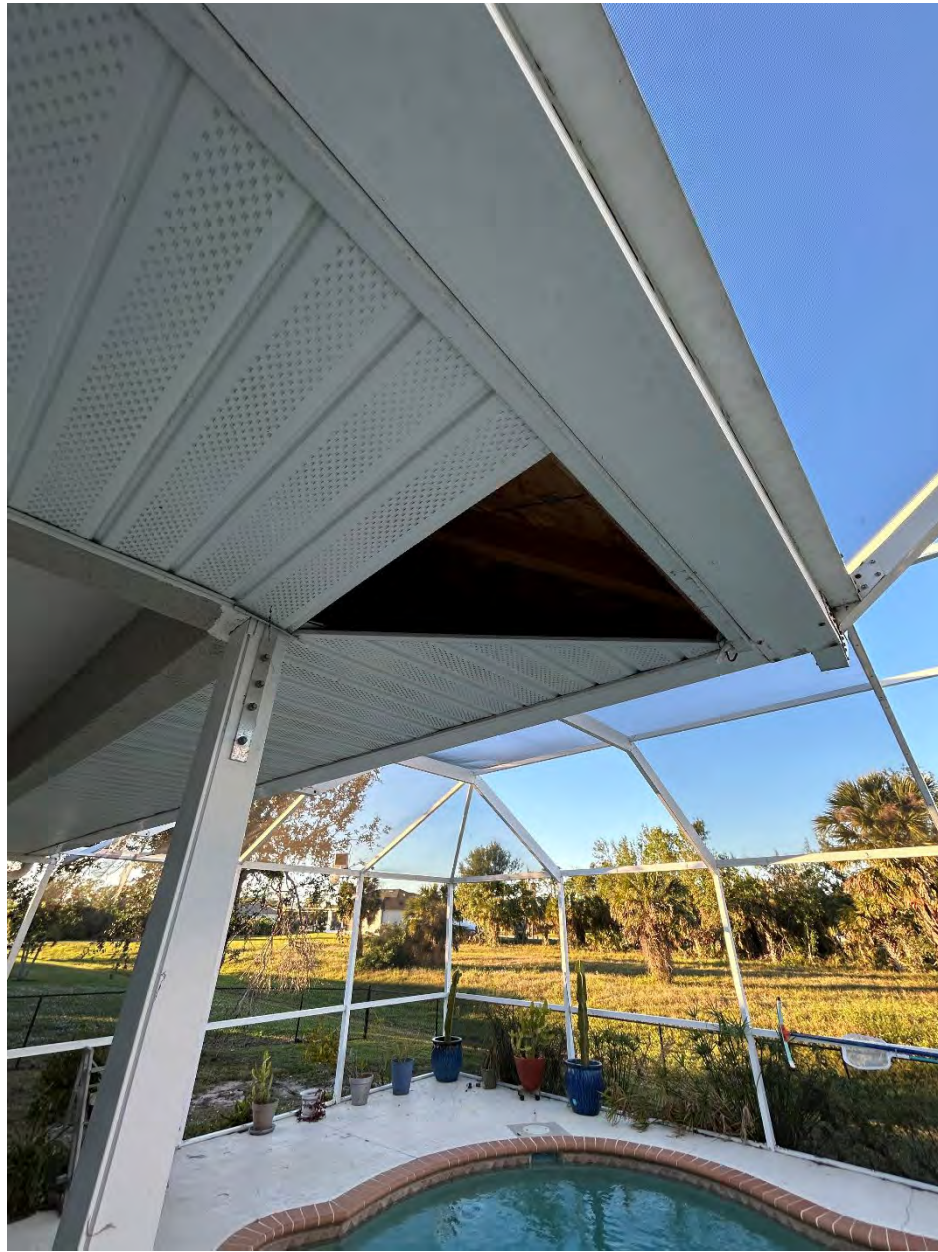
**ALUMINIUM ROOF**  
**STRUCTURAL DAMAGE POOL CAGE**

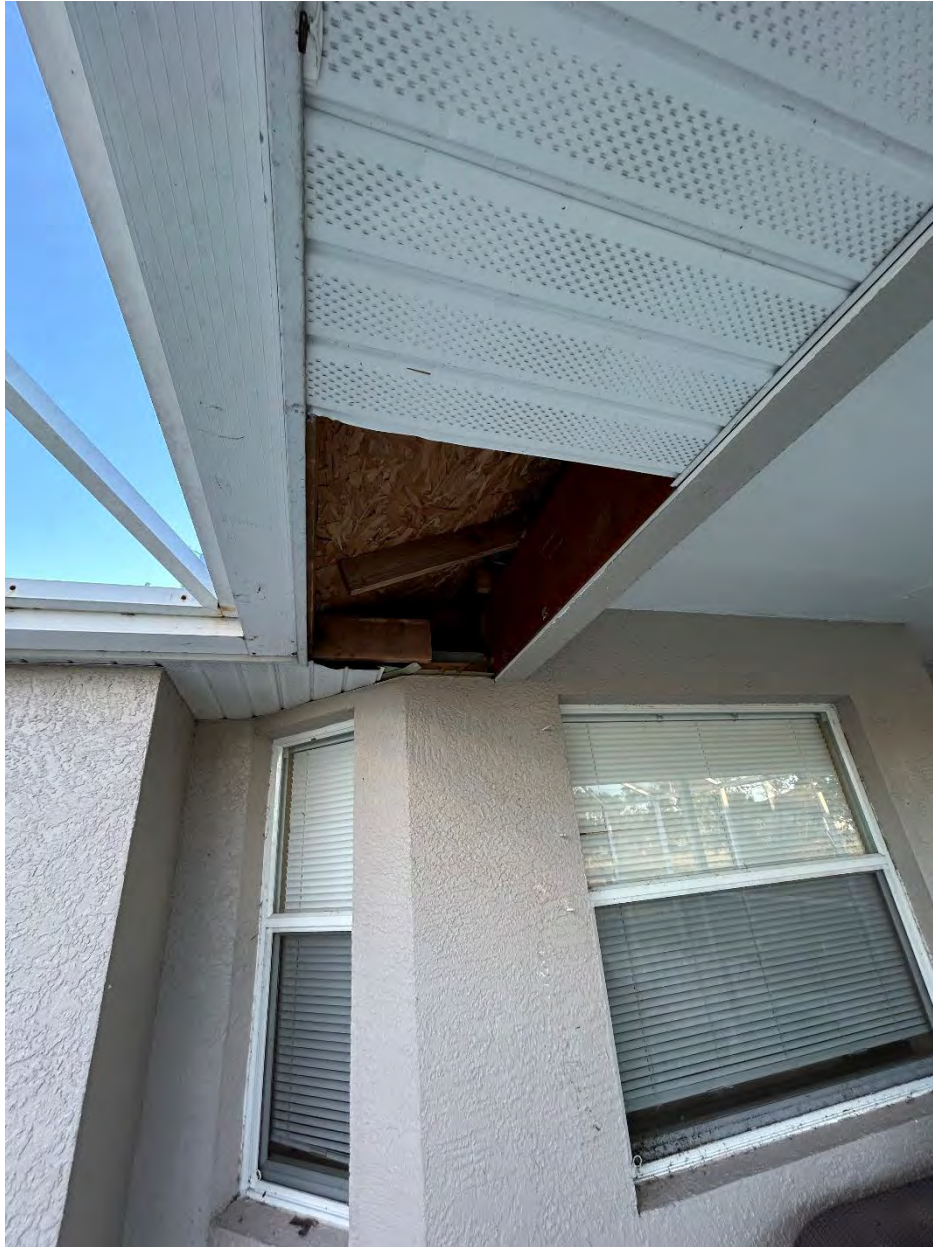
**INEXSTENT ROOF ALUMINIUM**

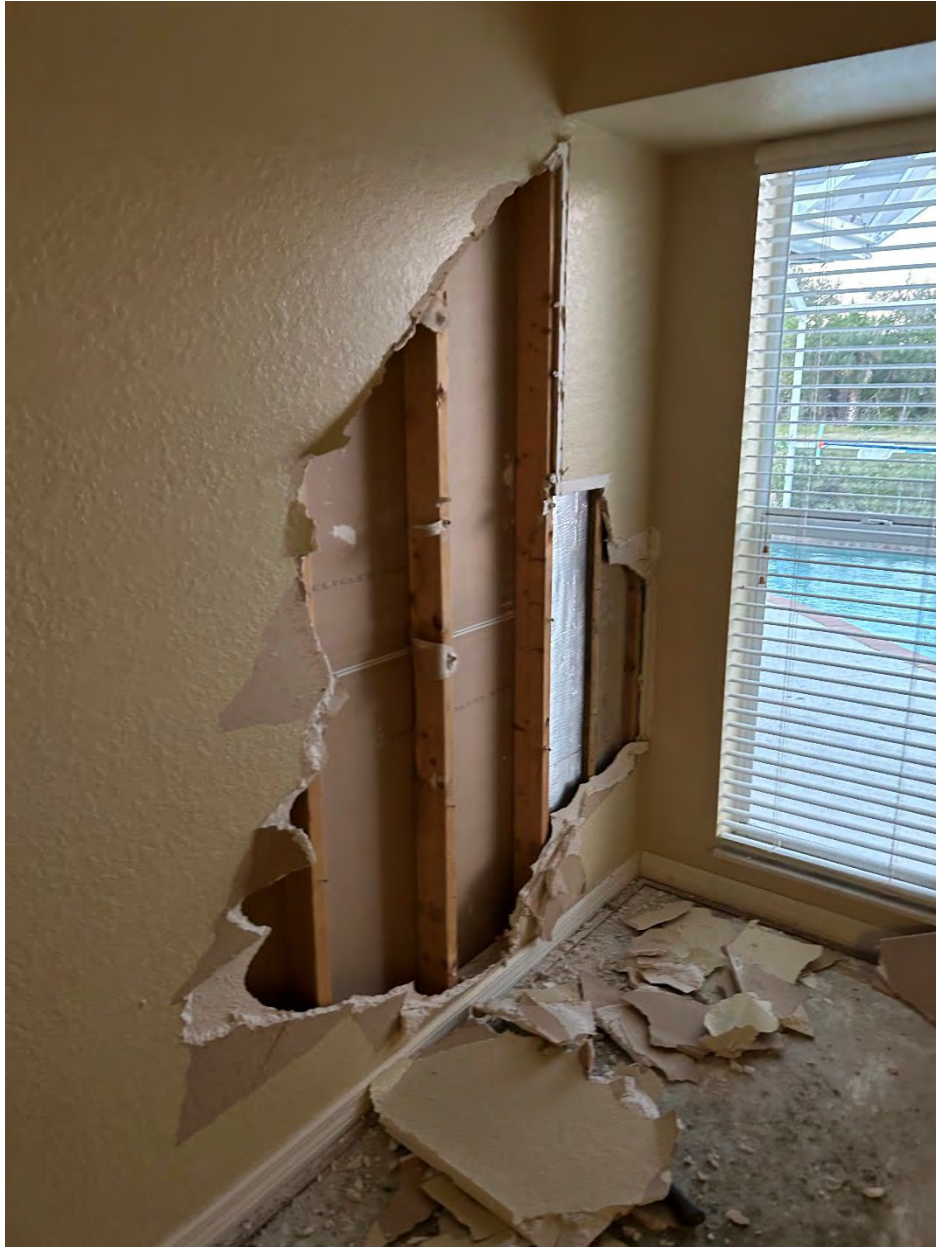
**MOLD, HUMIDITY ON WALLS AND INSULATION**  
**A/C DUCTS COMPROMIZED**

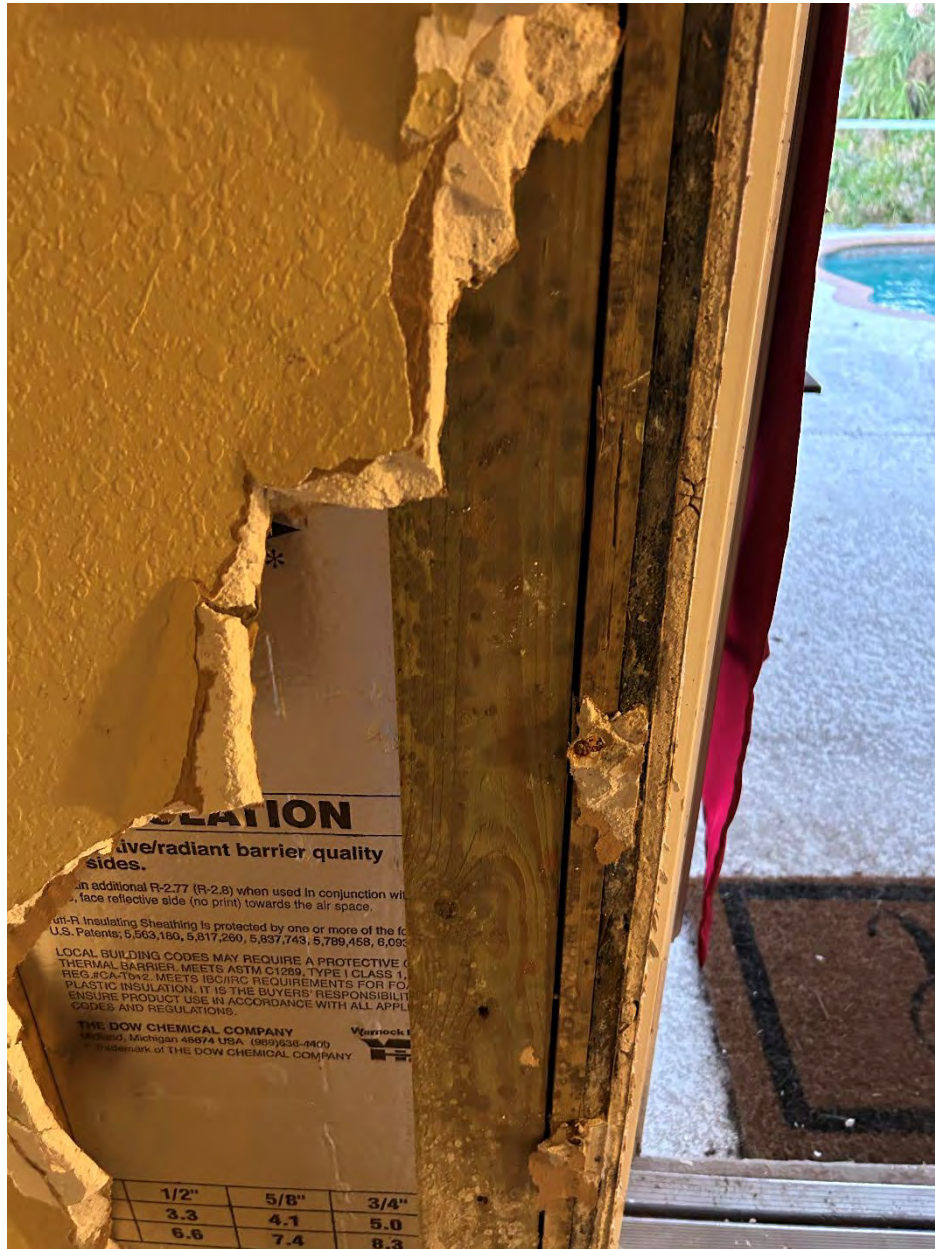
## MOLD, HUMIDITY ON WALLS AND INSULATION

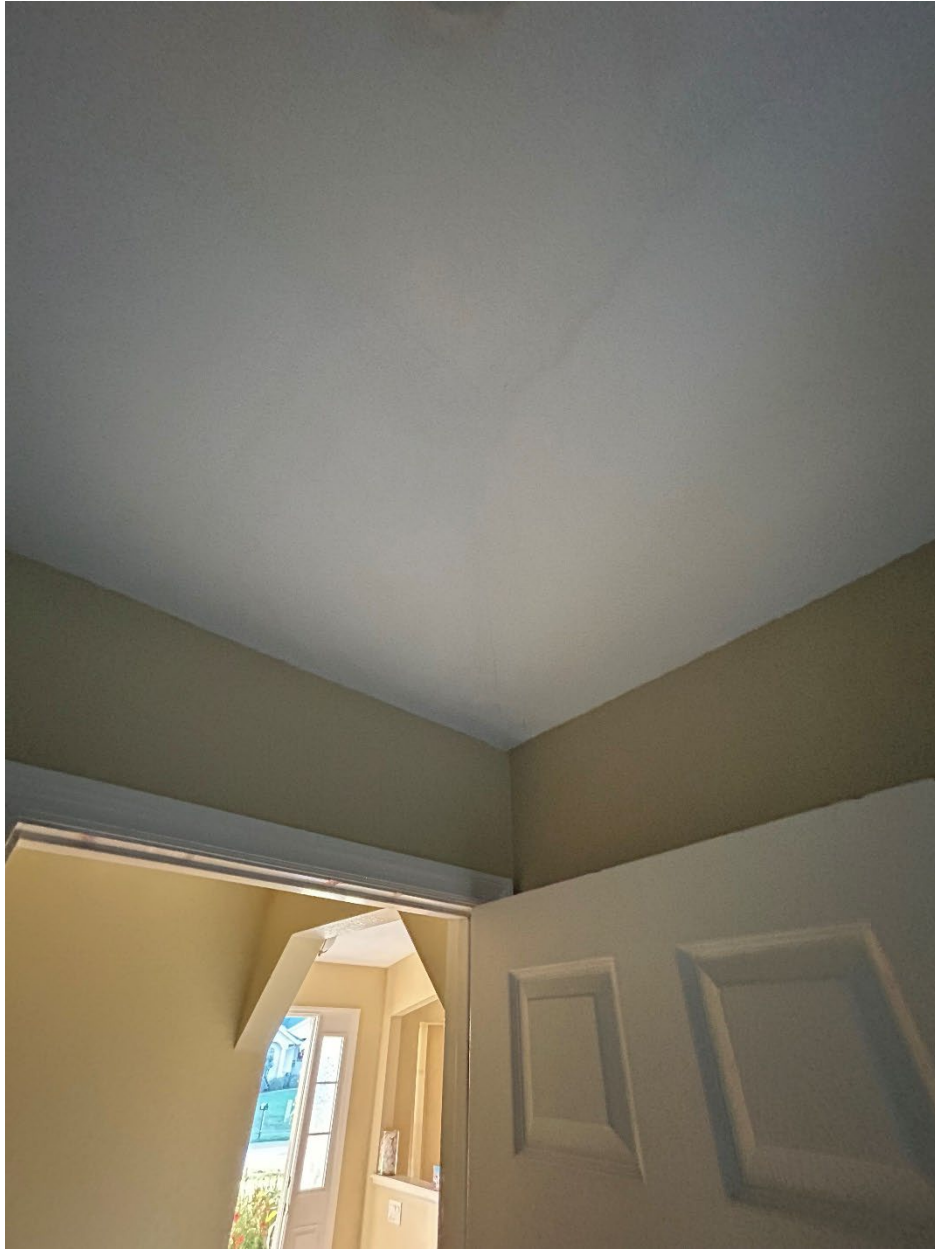
## HUMIDITY AND CRAKS ON CEILINGS
