Confidential Inspection Report

At your request, a visual inspection of the above referenced property was conducted on September 3, 2020. An earnest effort was made on your behalf to discover all visible defects, however, in the event of an oversight, maximum liability must be limited to the fee paid. The following is an opinion report, reflecting the visual conditions of the property at the time of the inspection only. Hidden or concealed defects cannot be included in this report. No warranty is either expressed or implied. This report is not an insurance policy, nor a warranty service.

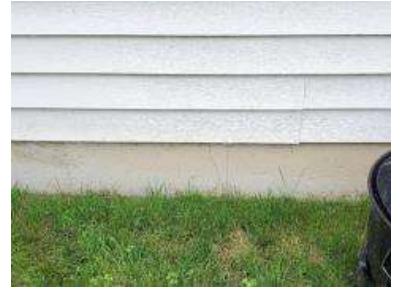
Minor cracks noted- not significant at this point in time, View of building 5.

It is recommended to seal the cracks at the transition in concrete under exterior doors of all buildings.

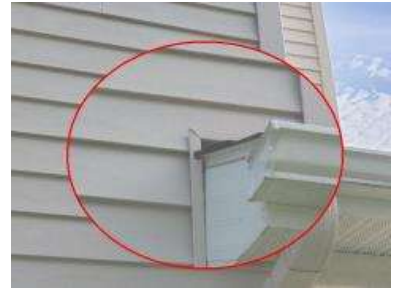
Building 5.

Damaged j channel is seen where it was cut to contour the shingle and drip edge. This area will need to be better sealed to prevent water entry behind the siding due to the cut j-channel. Signs of periodic leakage at the base of the foundation common to this area is seen most likely related to the cut j channels. It is recommended to speak with a professional siding contractor to determine if hidden damages exists behind the siding.

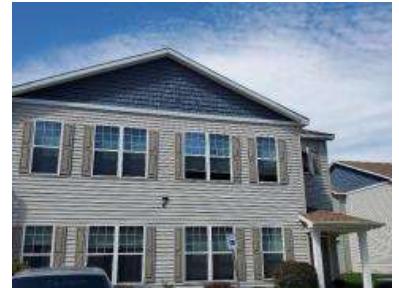
Building 7 has at least one bad thermal seal at the front window seen from the parking area.

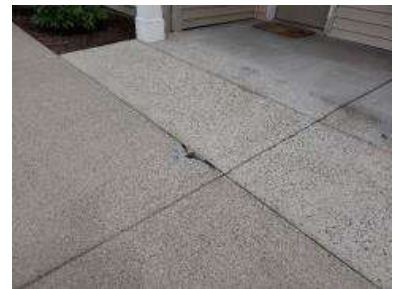
Building 4. Plumbing in the sidewalk presents a tripping hazard.

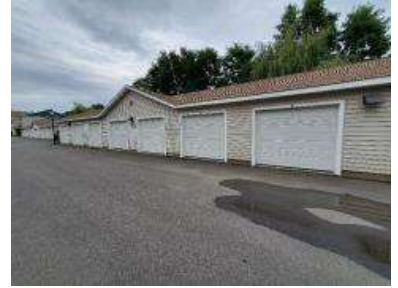
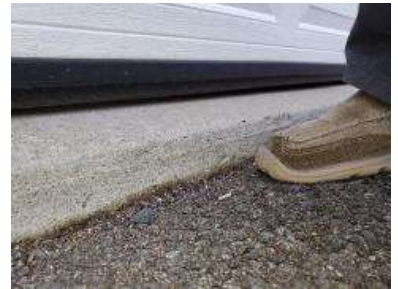
Trip hazards are noted at all garage entry transition points.

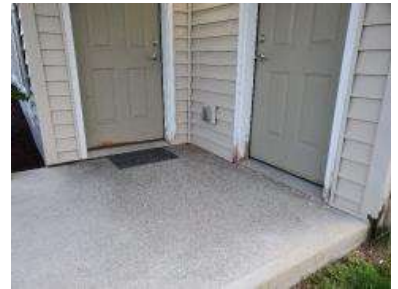
Building 4 minor peeling paint at exterior door trims and corner siding pieces.

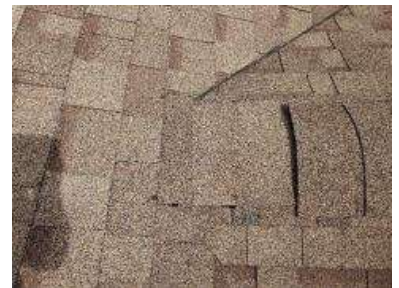
All roof slopes that face the Western direction have sustained what appears to be possible storm damage. This damage is consistent on all of these roofs, running along mainly the upper most section approximately 10 feet deep and the length of the roof.

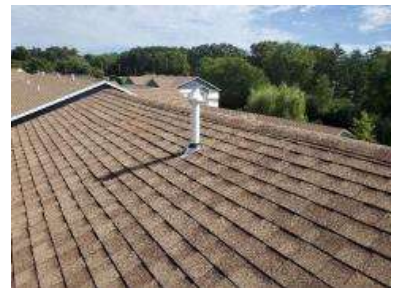
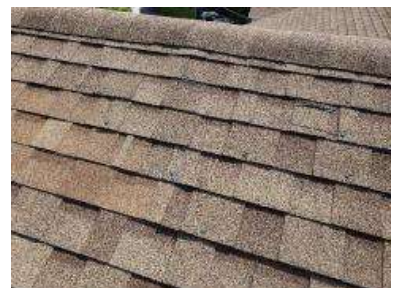
Multiple patches are seen with tar that appears to be where nails raised through the shingles creating holes or where shingles were face nailed.

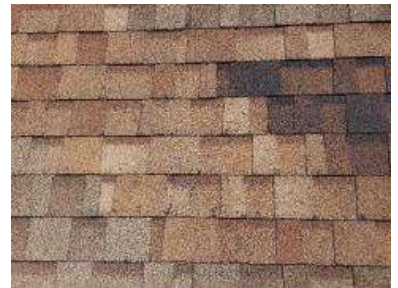
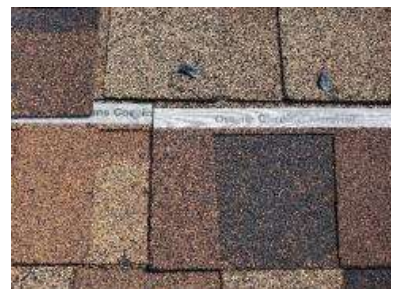
Abrasion on the patch can be seen indicating rough handling may have occurred from installer.

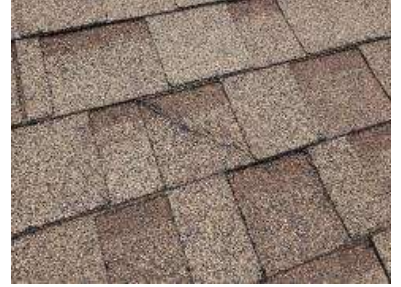
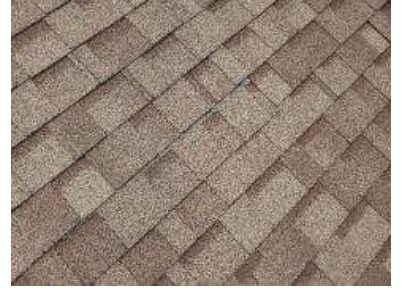
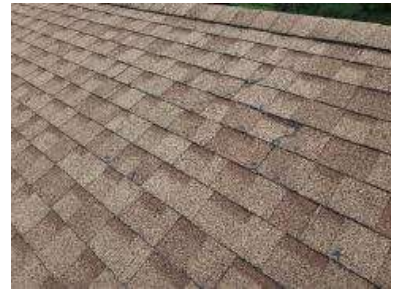
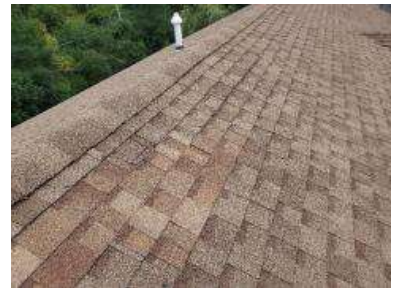
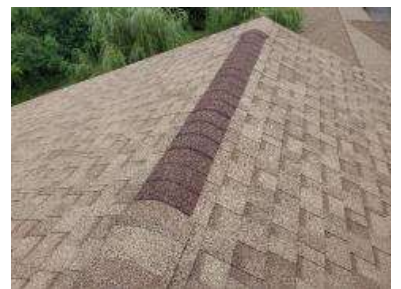
Loose tabs are seen.

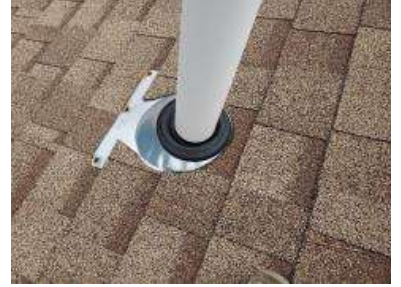
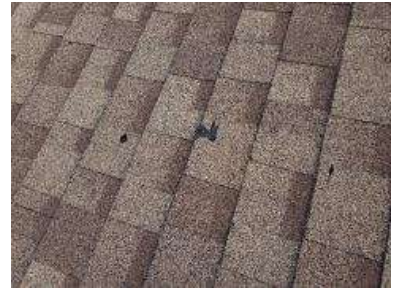
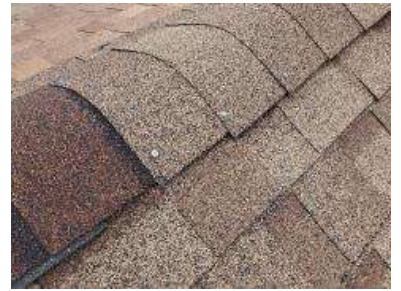
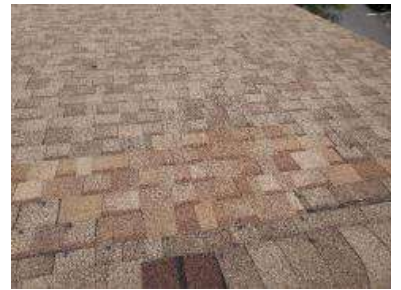
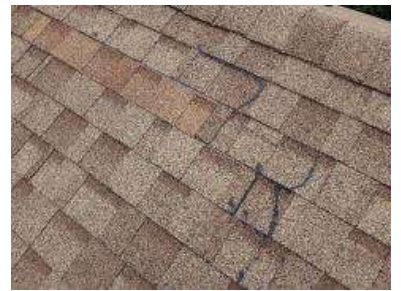
Crushed vent.

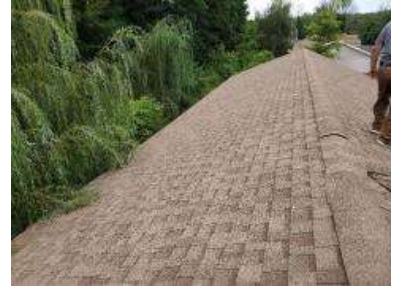
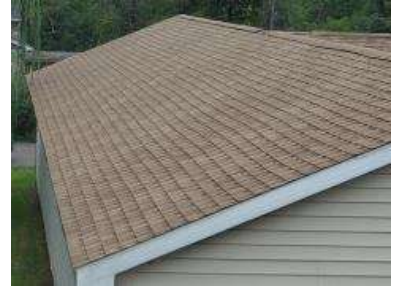
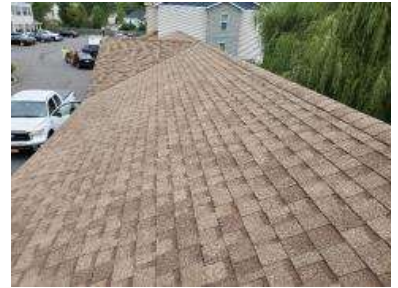
Damage at the garage room over unit 11.

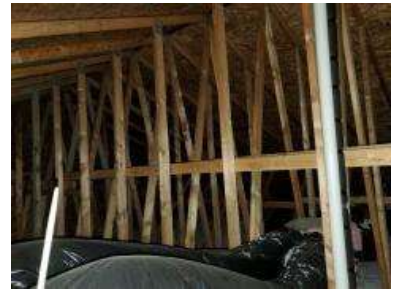
Viewing was limited to the hatch areas of all buildings. All attic hatches are spring loaded with a minimum 1 hour fire rating. There was no fire wall seen in the attic areas of each building, only OSB separating the upstairs apartments attic areas. It is reasonable to assume that a proper firewall (fire rated sheetrock) may need to be installed for safety and liability reasons. It is recommended to speak with the local building department and fire marshals for further inspection to determine if a fire wall between attics was needed in these buildings.

It is recommended to speak with the local building department and fire marshals for further inspection to determine if a fire wall between attics was needed in these buildings.

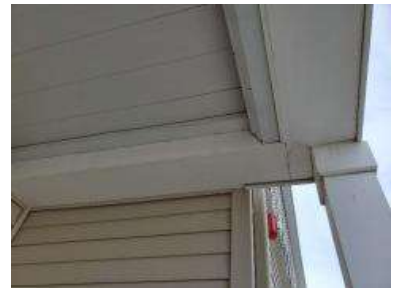
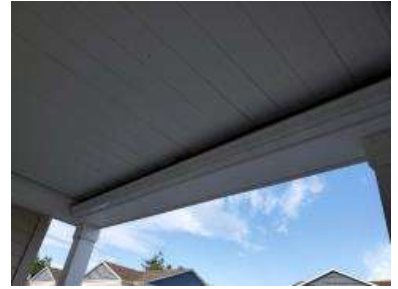
Adjustment to the underground corrugated piping should be considered to help prevent unnecessary debris from entering the system this can be seen at the front of the buildings. number 4. Periodic leakage is seen located under the 2nd floor balcony of buildings 4,5,7,9.

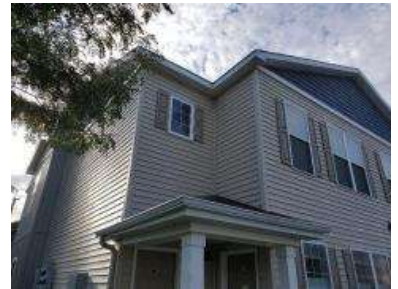
It is recommended to consider installing a gutter system on the upper portion of the roof to prevent unnecessary wear and tear on the lower Room entryways seen at all buildings.

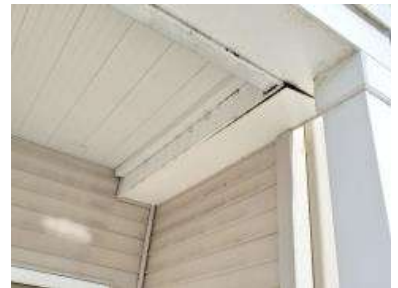
Active leakage appears to periodically occur. At building 5 entryway moss growth or remnant bird nesting is seen the lower soffit it is reasonable to assume hidden damage may be present.

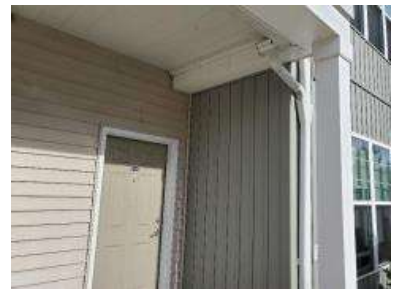
Active leakage is seen entering behind the siding at apartment 5103 the siding in this area was cut short. Moisture staining at the siding and soffit in this area as well as water staining at the interior wall common to the light switch is seen. This is indicating that periodic active leakage has penetrated into the interior wall from the exterior. (the tenant in this apartment has stated that active leakage in this wall does occur and water exits out of the light switch) Wall sheathing in this area is believed to be deteriorated behind the vinyl. As pressure is applied to the exterior walls at buildings 5,7 and 9(on siding below the balcony's) a significant deflection in the exterior walls is felt which indicates hidden damage is most likely present. A Professional siding company will need to determine the extent of damages and source of

the leaks at ALL buildings.

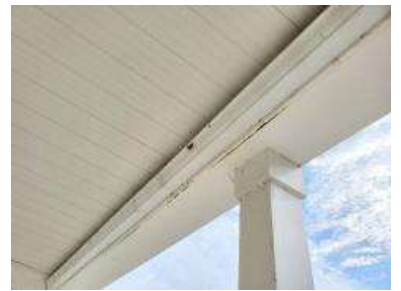
Building 7 leakage.

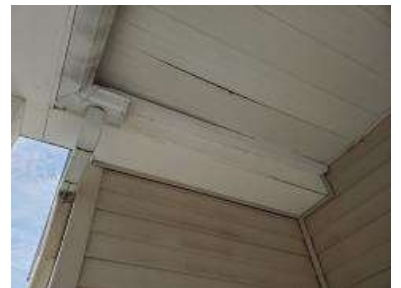
Building 9 leakage at soffit.

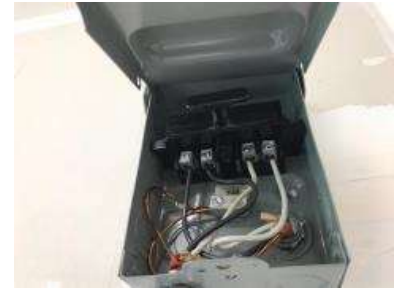
Disconnect boxes are in general serviceable condition with the exception of building 7 the left unit is missing the cover.

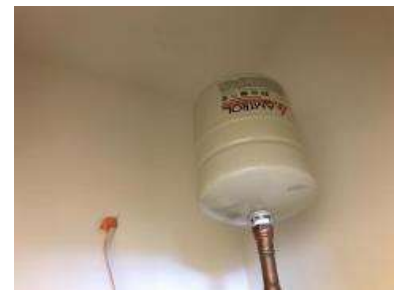
Flooded expansion tank is suspected and a replacement tank may be needed.

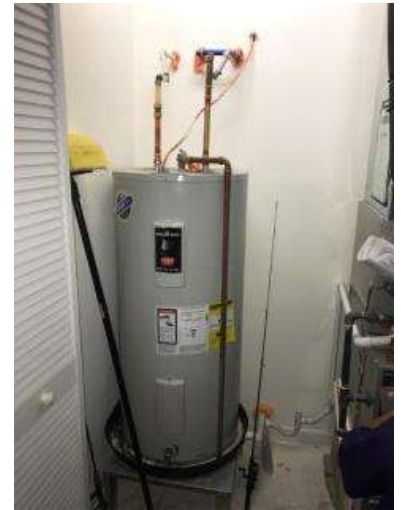
7101. Recently installed.
Sediment in drip pan. Corrosion noted on the supply lines. Monitor for potential leaks on the supply lines and make repairs as needed.

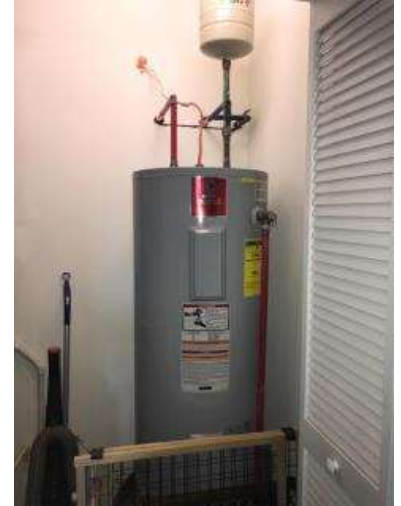
4101. Active leaks on supply lines. Repairs are needed.

- Periodic active leakage is seen at the supply lines to water heaters at units 4101, 4201, 4203.

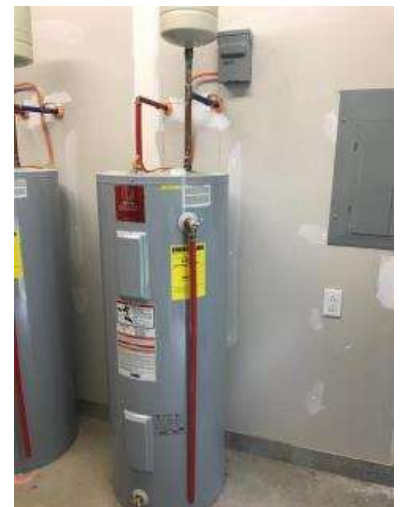
4201. Periodic leakage. Flooded expansion tank.

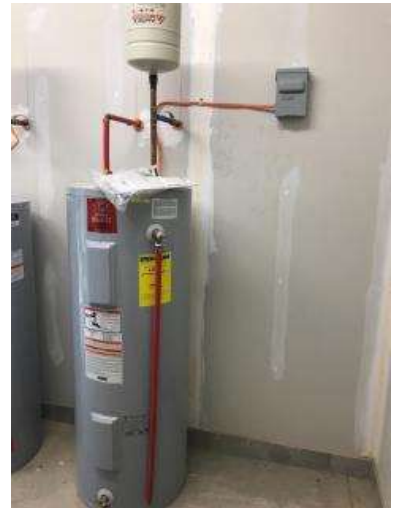
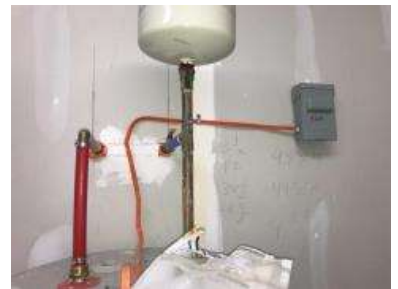
4203. Corrosion periodic leaks are occurring most likely due to a flooded expansion tank.

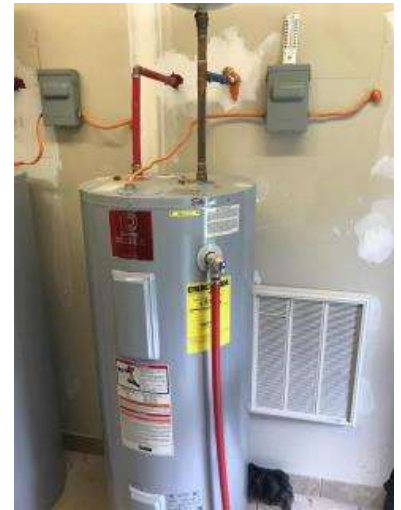
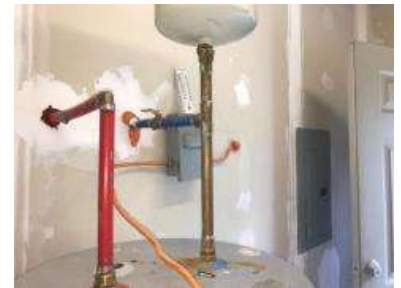
5205, 5202 Corrosion periodic leaks are occurring most likely due to a flooded expansion tank.

- Replacement expansion tanks may be needed for units 7104, 5104, 4103, 5205, 5202 in addition to 4101, 4201, 4203.

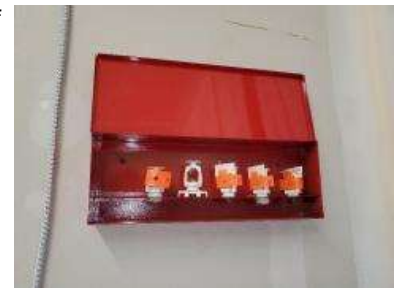
Missing sprinkler head noted in emergency box of building 4.
