Confidential Inspection Report

At your request, a visual inspection of the above referenced property was conducted on September 3, 2020. An earnest effort was made on your behalf to discover all visible defects, however, in the event of an oversight, maximum liability must be limited to the fee paid. The following is an opinion report, reflecting the visual conditions of the property at the time of the inspection only. Hidden or concealed defects cannot be included in this report. No warranty is either expressed or implied. This report is not an insurance policy, nor a warranty service.

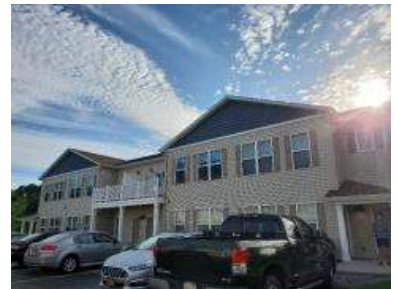
Minor damage believed to be related to landscaping maintenance that has occurred. Repairs to siding are recommended to prevent moisture entry. Buildings 4,5.

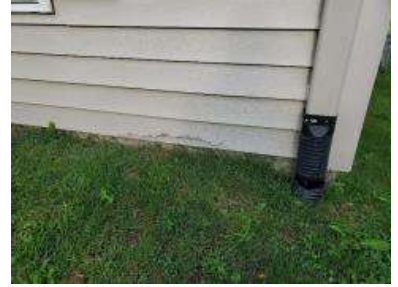
Building 5.

Damaged j channel is seen where it was cut to contour the shingle and drip edge. This area will need to be better sealed to prevent water entry behind the siding due to the cut j-channel. Signs of periodic leakage at the base of the foundation common to this area is seen most likely related to the cut j channels. It is recommended to speak with a professional siding contractor to determine if hidden damages exists behind the siding.

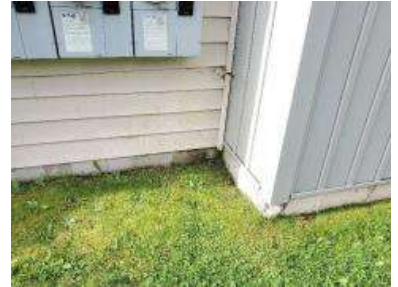
Loose siding will need to be re-secured at various portions of the garage exterior.

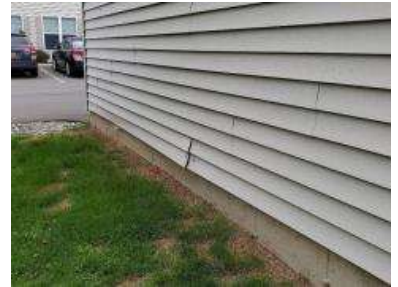
The garage siding is cut short at the rear, corrections are recommended.

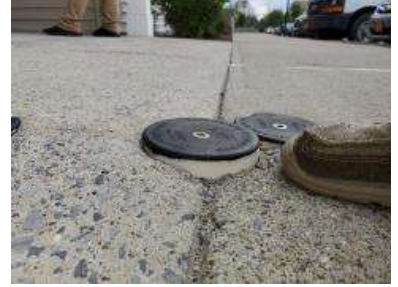
Trip hazards are noted at all garage entry transition points.

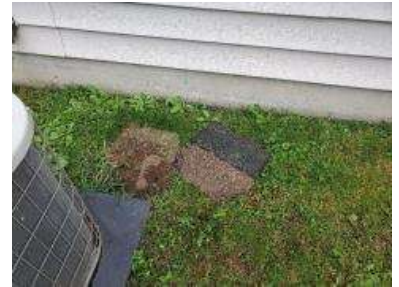
Torn shingles are seen on the ground behind building 9. The shingle where it was lying on the ground had no grass beneath it. This indicates damage to the roof may have occurred weeks or months prior. Speak with the building owner to determine the history of potential storm damage that may have occurred in the past.

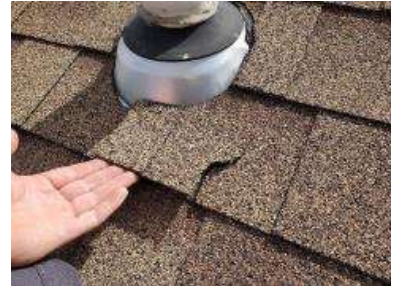
Torn shingles seen at rear building 9 at far right sewer vent.

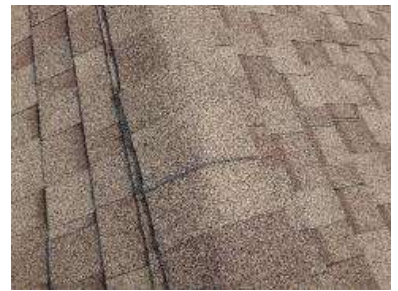
Ridge top nailing at Building 9.

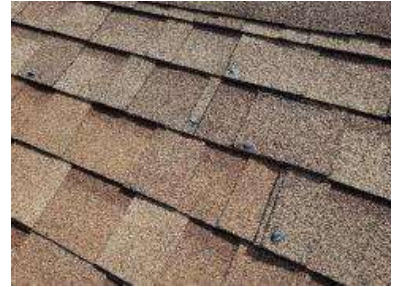
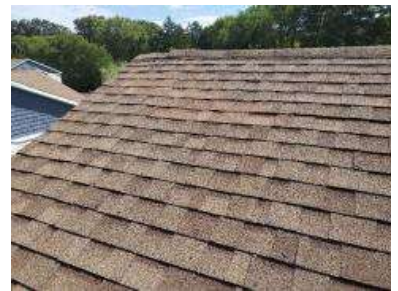
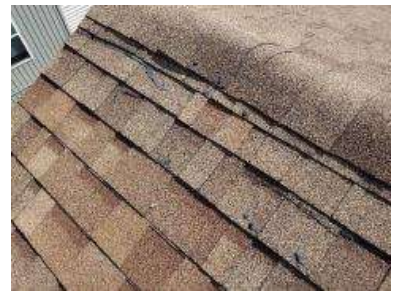
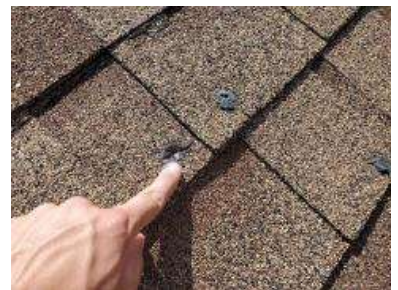
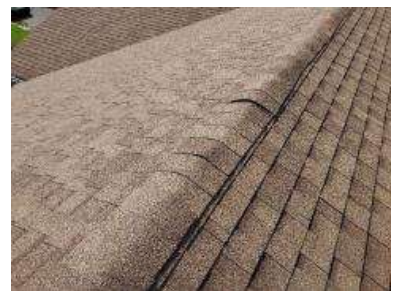
Multiple patches are seen with tar that appears to be where nails raised through the shingles creating holes or where shingles were face nailed.

Tar patching should only be considered a temporary patch, it is reasonable to assume leakage will occur in the future.

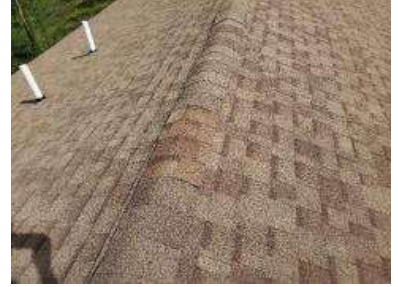
- Building 9: There was an improper patch/ repair to the ridge vent that is using roofing shingles where ridge cap shingles are needed. Eventual leakage will occur proper repair is needed.
- Building 5: Has collapsed sewer vent flashings (rubber flange) that will allow eventual leakage.

Building 9. Improper ridge cap installation is seen where roofing shingles were used in place of ridge cap shingles.

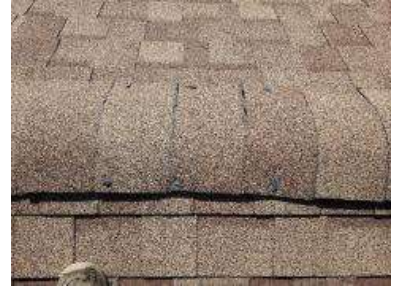
View of top nailing at Building 7.

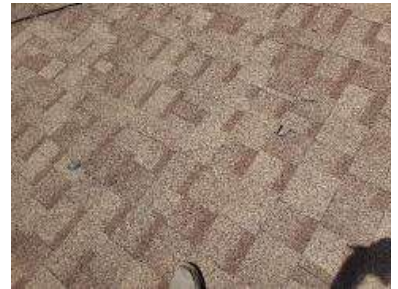
Torn shingle Building 7.

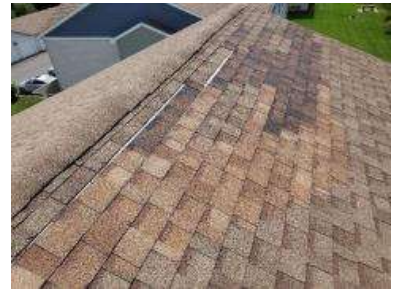
Building 5 patch slipped shingles.

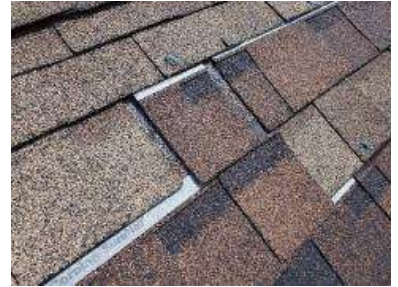
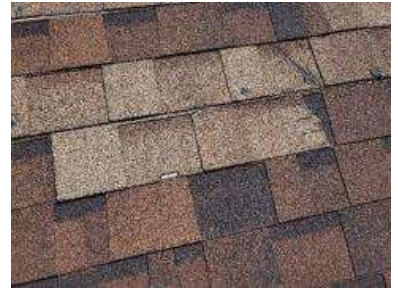
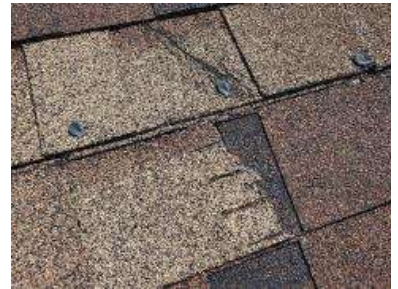
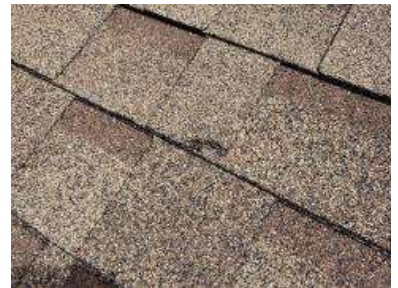
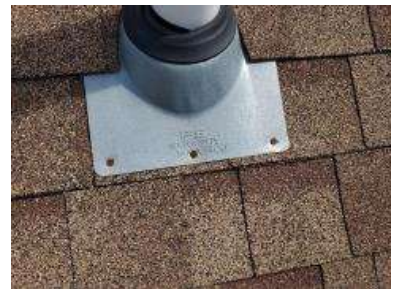
Abrasion on the patch can be seen indicating rough handling may have occurred from installer.

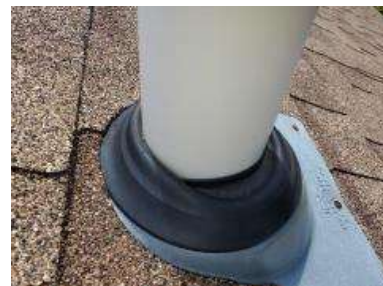
Collapsed sewer vent boot. Eventual leakage may occur.

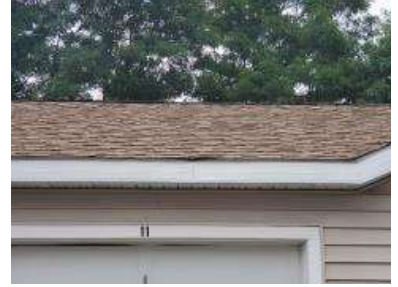
Damage at the garage room over unit 11.

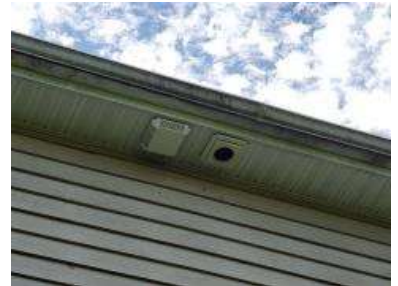
Aluminum/Aluminum, Missing covers on various exterior bathroom vents at the soffits will need to be replaced.

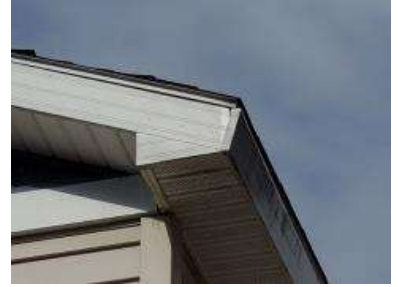
Loose fascia flashing will need to be secured at building 9.

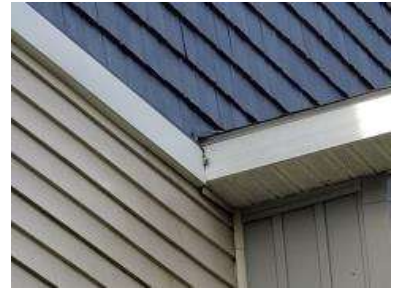
Moss growth seen at the right side of building 9 at the fascia.

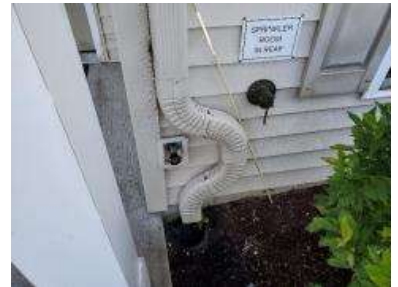
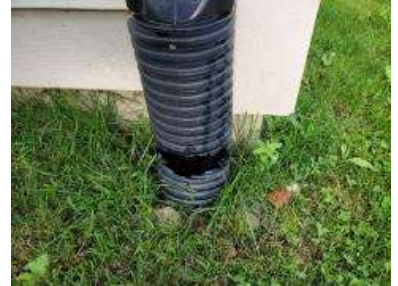
Adjustment to the underground corrugated piping should be considered to help prevent unnecessary debris from entering the system this can be seen at the front of the buildings. number 4. Periodic leakage is seen located under the 2nd floor balcony of buildings 4,5,7,9.

It is recommended to consider installing a gutter system on the upper portion of the roof to prevent unnecessary wear and tear on the lower Room entryways seen at all buildings.

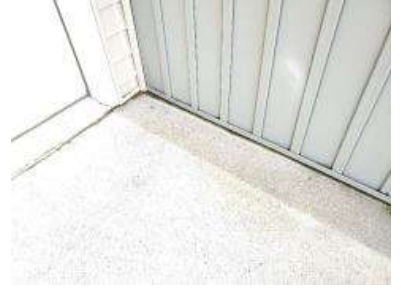
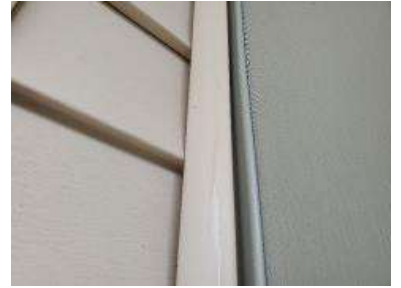
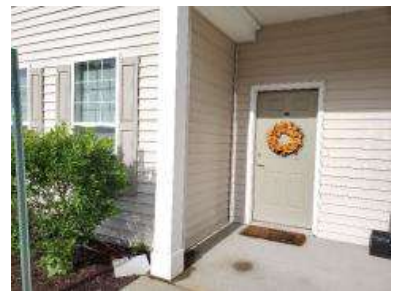
Active leakage is seen entering behind the siding at apartment 5103 the siding in this area was cut short. Moisture staining at the siding and soffit in this area as well as water staining at the interior wall common to the light switch is seen. This is indicating that periodic active leakage has penetrated into the interior wall from the exterior. (the tenant in this apartment has stated that active leakage in this wall does occur and water exits out of the light switch) Wall sheathing in this area is believed to be deteriorated behind the vinyl. As pressure is applied to the exterior walls at buildings 5,7 and 9(on siding below the balcony's) a significant deflection in the exterior walls is felt which indicates hidden damage is most likely present. A Professional siding company will need to determine the extent of damages and source of

Building 7 leakage.

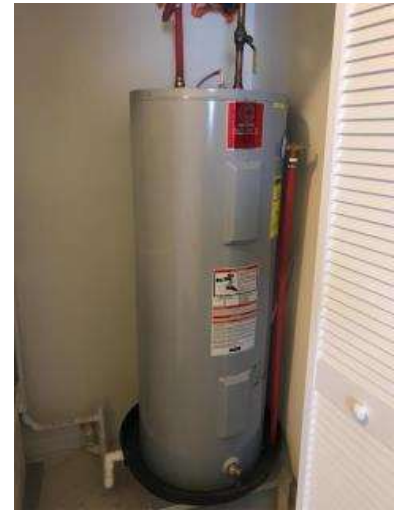
Flooded expansion tank is suspected and a replacement tank may be needed.

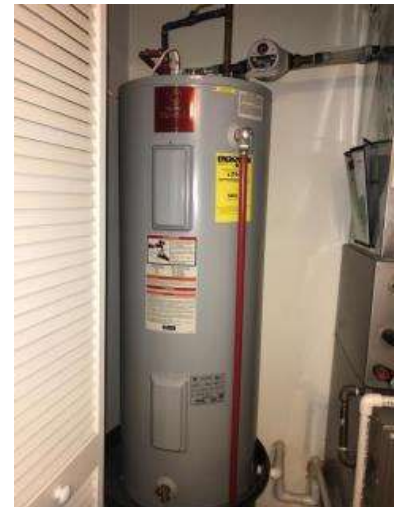
5104. Flooded expansion tank.

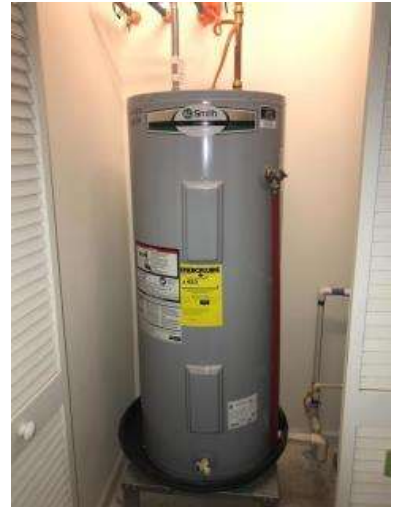
5101. Newer unit, Recently installed. 7/28/2020.

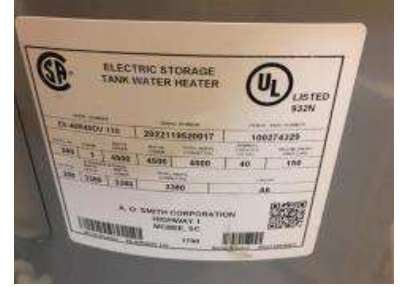
Data Plate. A.O. Smith Corporation.

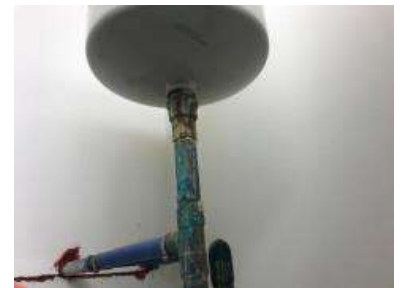
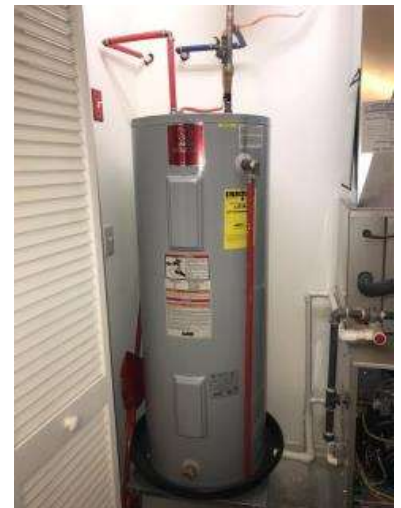
Close up view.

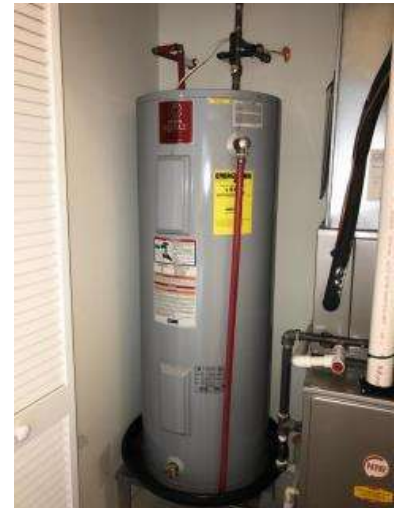
4103. Expansion tank flooded.

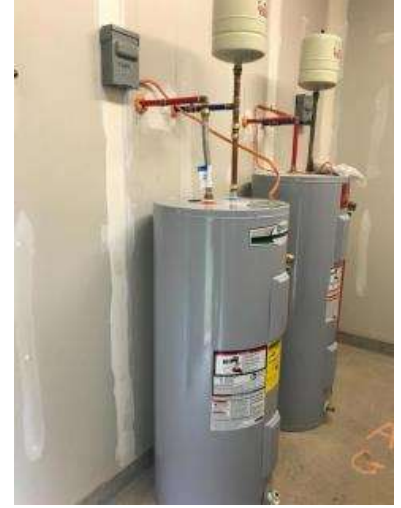
4204. Recently Replaced.

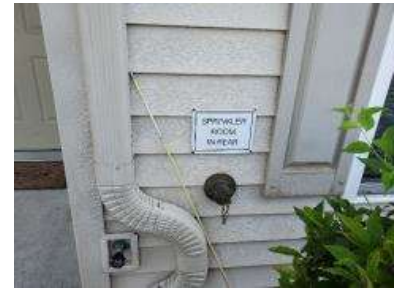
Labeled and located at the front exterior of all habitable buildings
View of building 4.

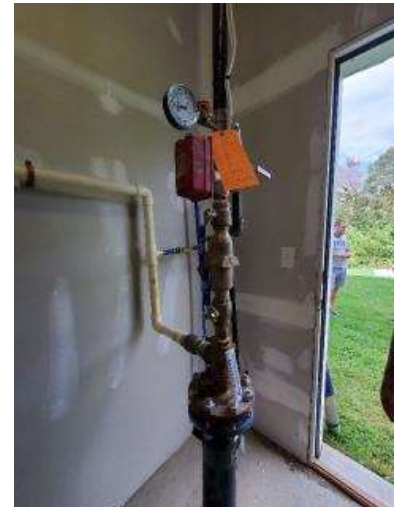
Building 7
Fire system was last serviced 7/19/19.

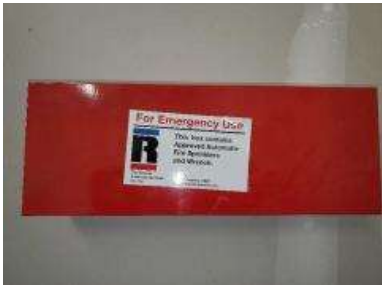
Emergency box with sprinklers. Wrenches and sprinkler heads are missing from the box at building 4,7,9 These emergency boxes should be fully equipped for safety and liability reasons.

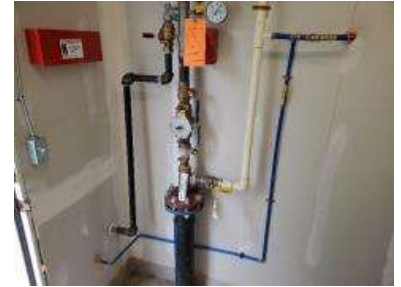
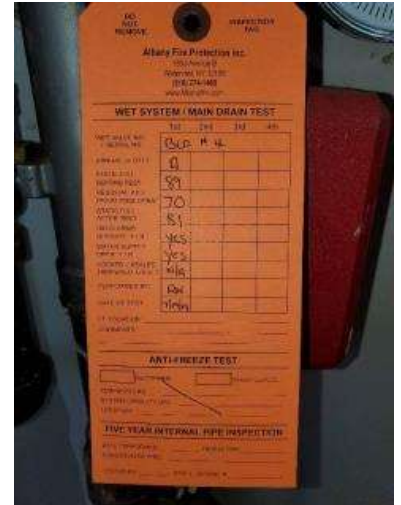
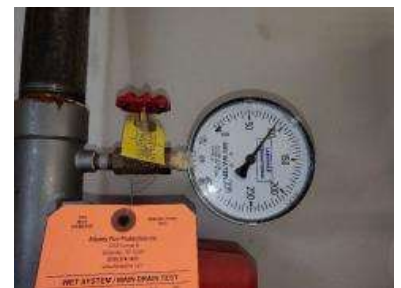
Missing sprinkler head noted in emergency box of building 4.

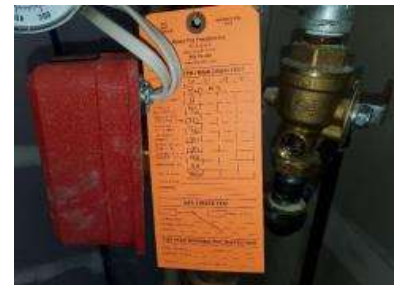
Service Tag.

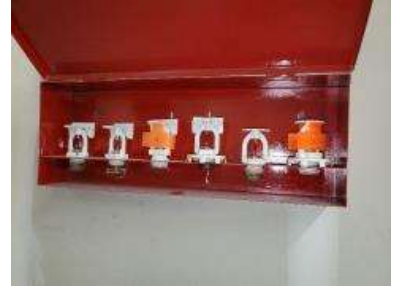
Missing wrench.
